# REMEDIAL SITE ASSESSMENT DECISION - EPA REGION IV

EPA ID: ALSFN0407150 Site Name: ANNISTON SCRAP

Report Type: SITE REASSESSMENT 001

**PRELIMINARY ASSESSMENT  
ANNISTON SCRAP  
ANNISTON, CALHOUN COUNTY, ALABAMA  
CERCLIS SITE REF. No.: 7150**

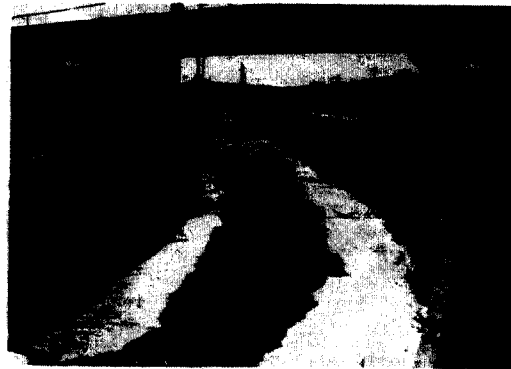
- Photo 14 Drainage ditch that forms part of the surface water pathway for the site. Photo taken near southwest corner of the site; facing south. Note Highway 202 in the background.

Photo 14: Drainage ditch that forms part of the surface water pathway for the site. Photo taken near southwest corner of the site; facing south. Note Highway 202 in the background.

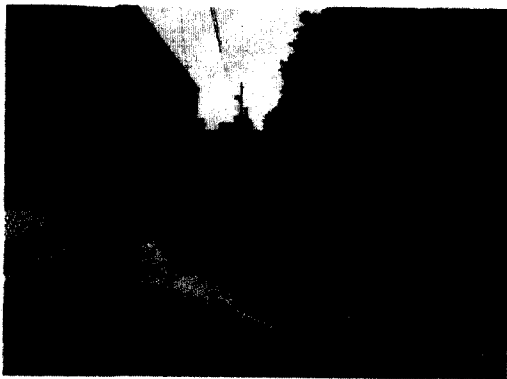
Photo 15: Southern boundary of site; facing east from the southwest corner of the site. Note the drainage ditch running along the fence line.

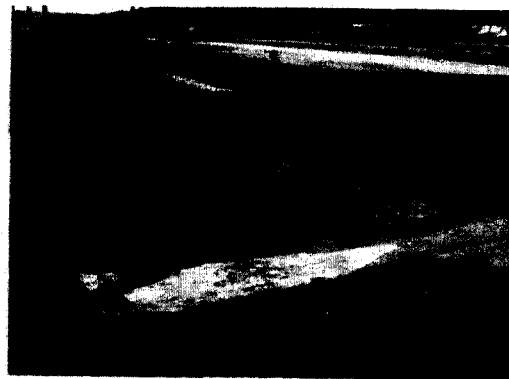
Photo 16: Drainage ditch from Photo 15. This ditch empties into the larger drainage ditch running south. This is the PPE for the surface water pathway.

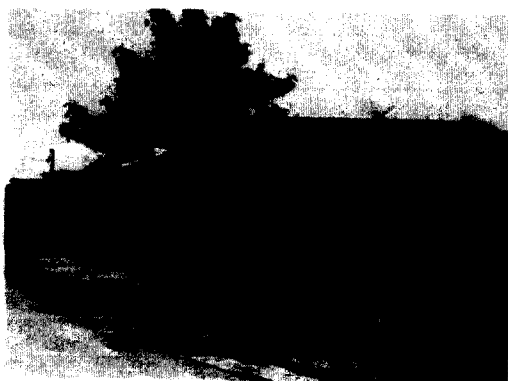
Photo 23: ACW building along Gurnee Ave.; facing southeast from alley. Building is very dilapidated and did not appear to be in use.

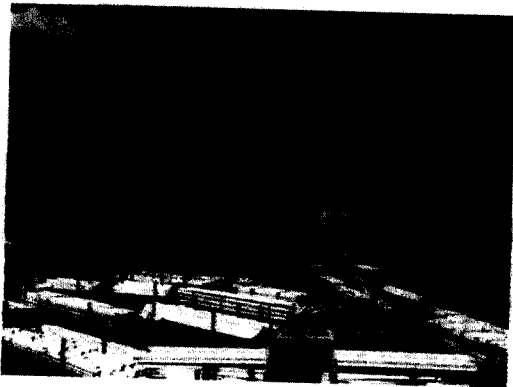
Photo 31: View of Southern Pipe and Supply Co. storage yard, located north of the main office; facing west from Gurnee Ave.

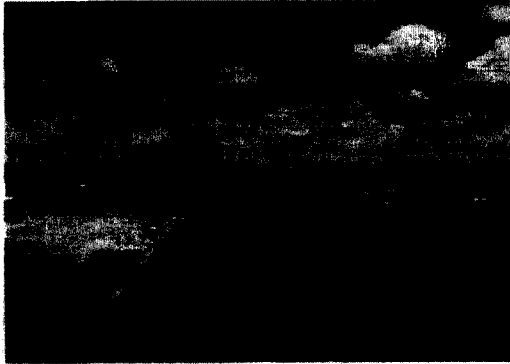
**Photo 33: View of railroad line bisecting the east and west portions of the site; facing north from Highway 202.**

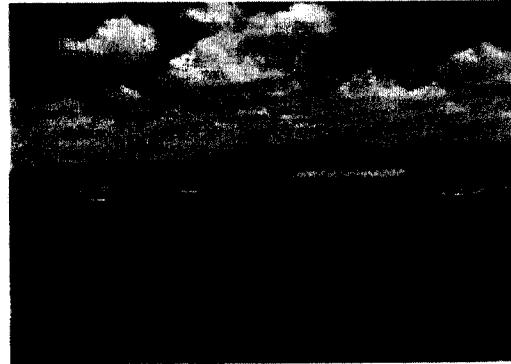
**Photo 34: View of eastern portion of the site; facing northeast from Highway 202.**
